UISENIS WIND FARM FISH HABITAT SURVEY REPORT

OUTER HEBRIDES FISHERIES TRUST

1/12/2022

Gavia Environmental

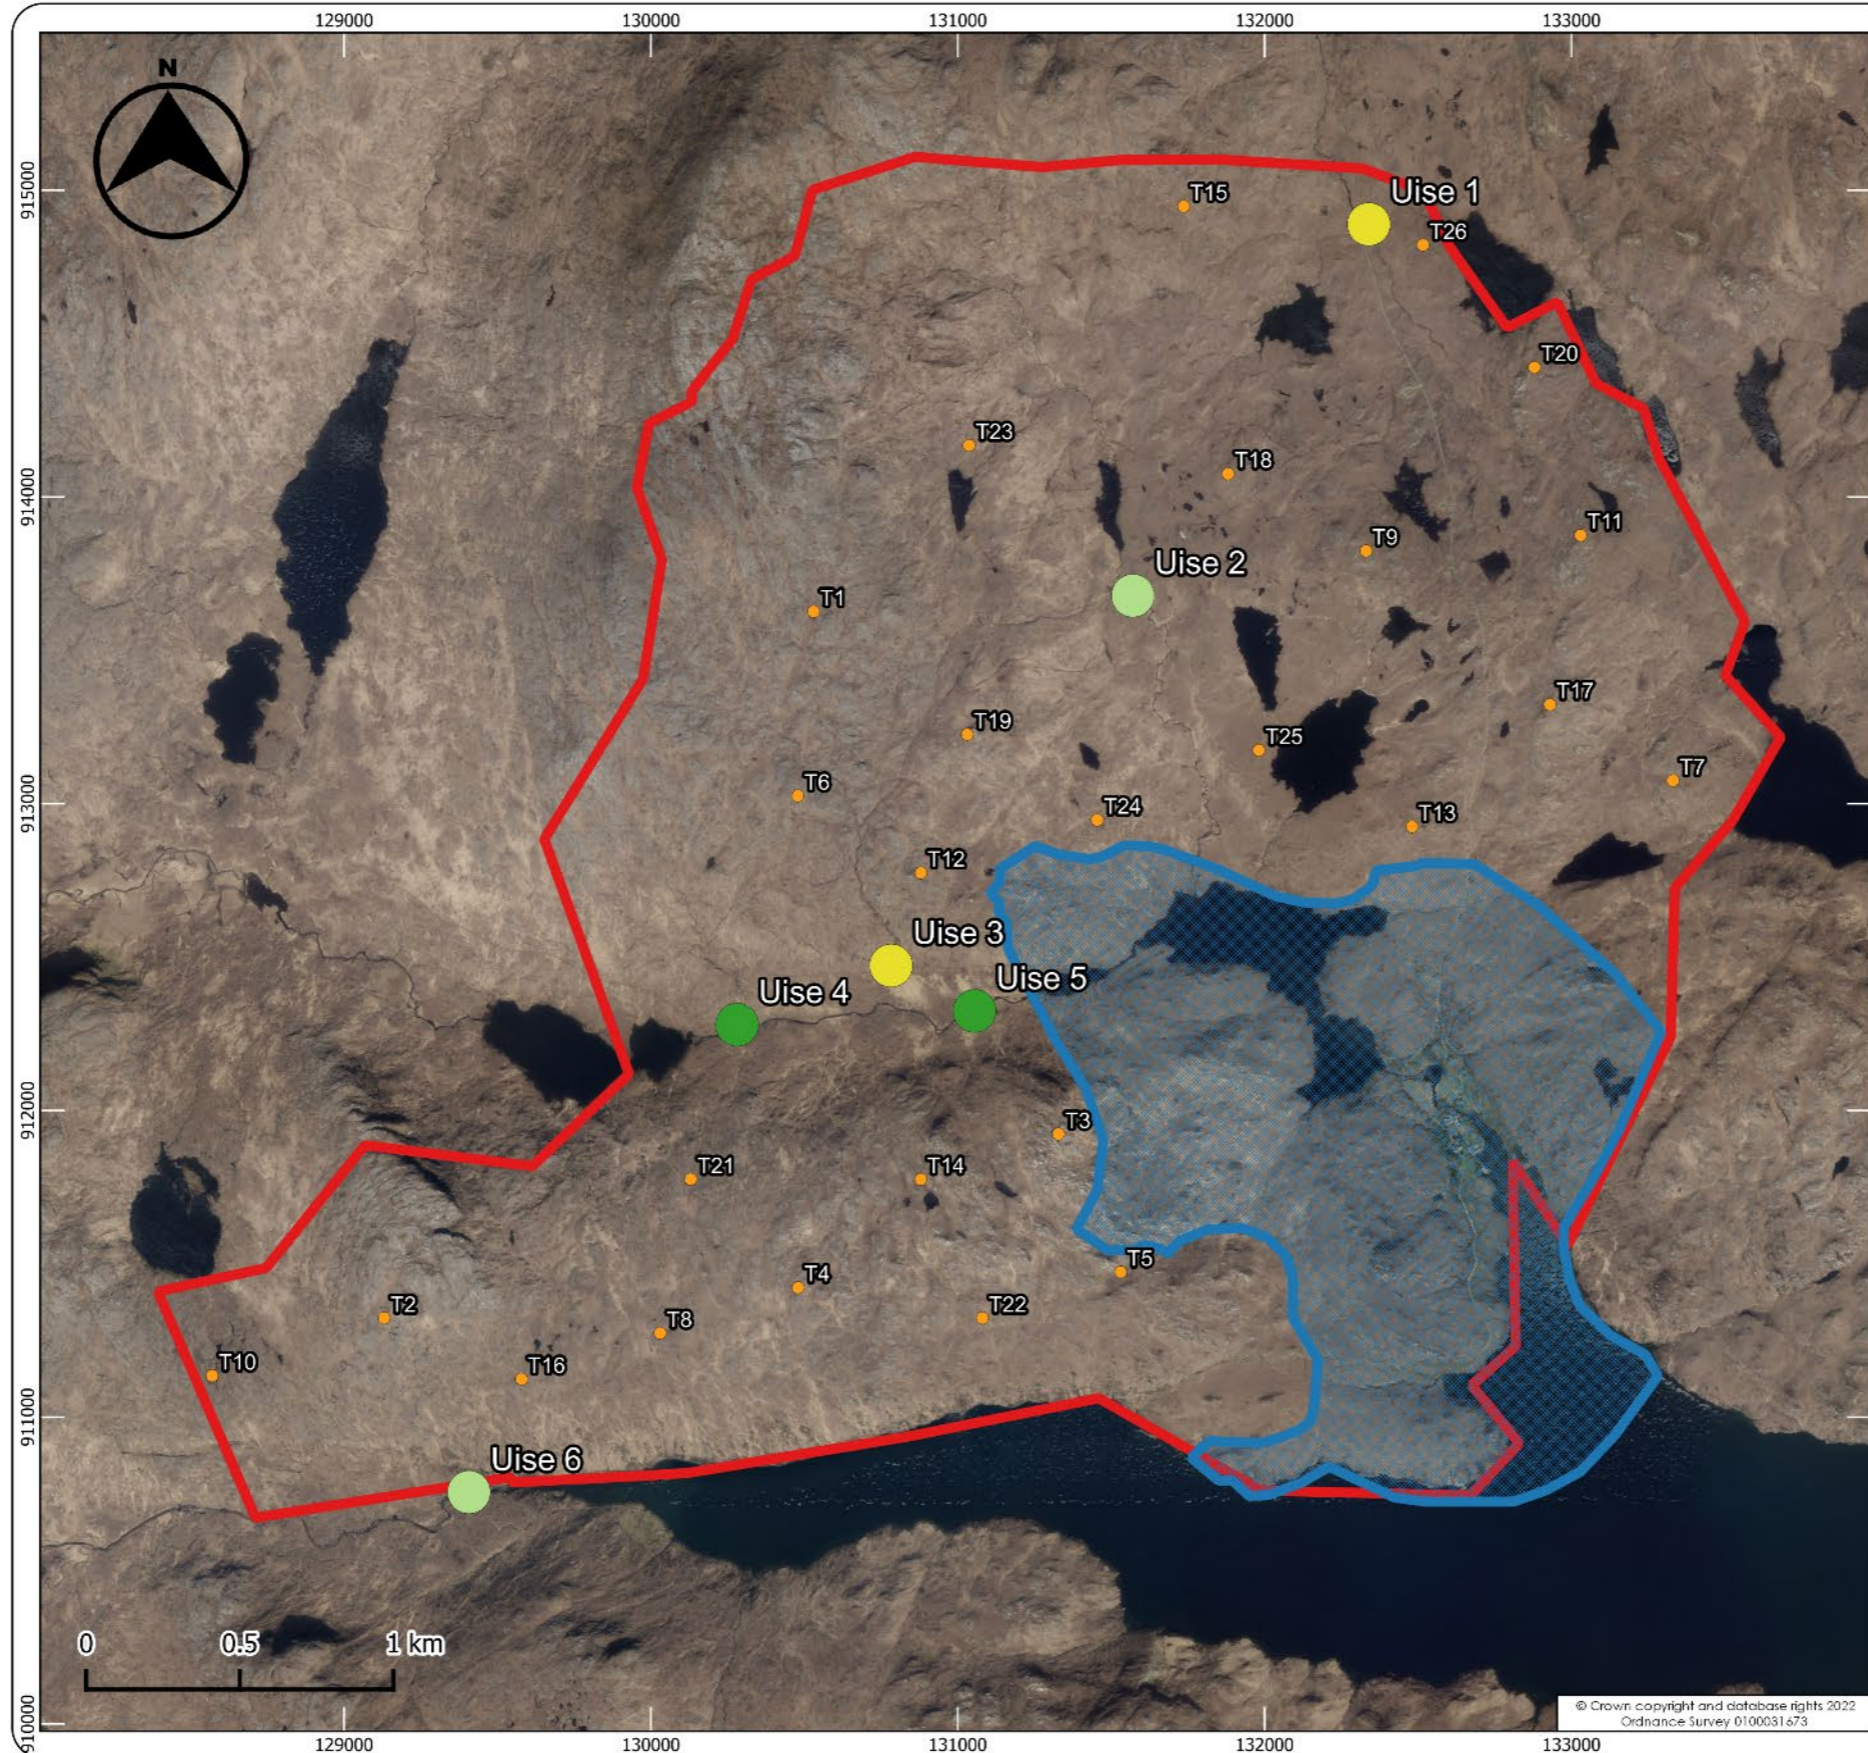
Figure Title: Uisenis Fish Habitat

Fish habitat survey results ranged from High (Uise 4 and Uise 5), Good (Uise 2 and Uise 6) and Moderate (Uise 1 and Uise 3). No Poor or Low fish habitats were identified.

- High
- Good
- Moderate

Based on this assessment, electrofishing surveys are recommended for survey locations Uise 2, Uise 4, Uise 5 and Uise 6 to provide baseline data for the salmonid population densities and to further inform the species community assemblage present within the Site. Moreover, it is recommended that "control site(s)" are established during baseline electrofishing, i.e. locations outwith the potential sphere of influence of the development. The objective of the "control site(s)" are to record any effects that are catchment based and not directly attributable to the proposed Development. These controls will be able to assess whether changes in fish population structure is a wider catchment based effect or one directly attributable to the proposed Development. Macroinvertebrate surveys are proposed as a biological water quality monitoring parameter and to assess prey resources for fish present in survey locations Uise 2, Uise 4, Uise 5 and Uise 6. Redd counts are additionally proposed for survey locations Uise 2, Uise 3, Uise 4 and Uise 5 during known spawning periods (November to January) to assess spawning utilisation of survey locations and to determine relative importance of survey locations in sustaining overall salmonid populations.

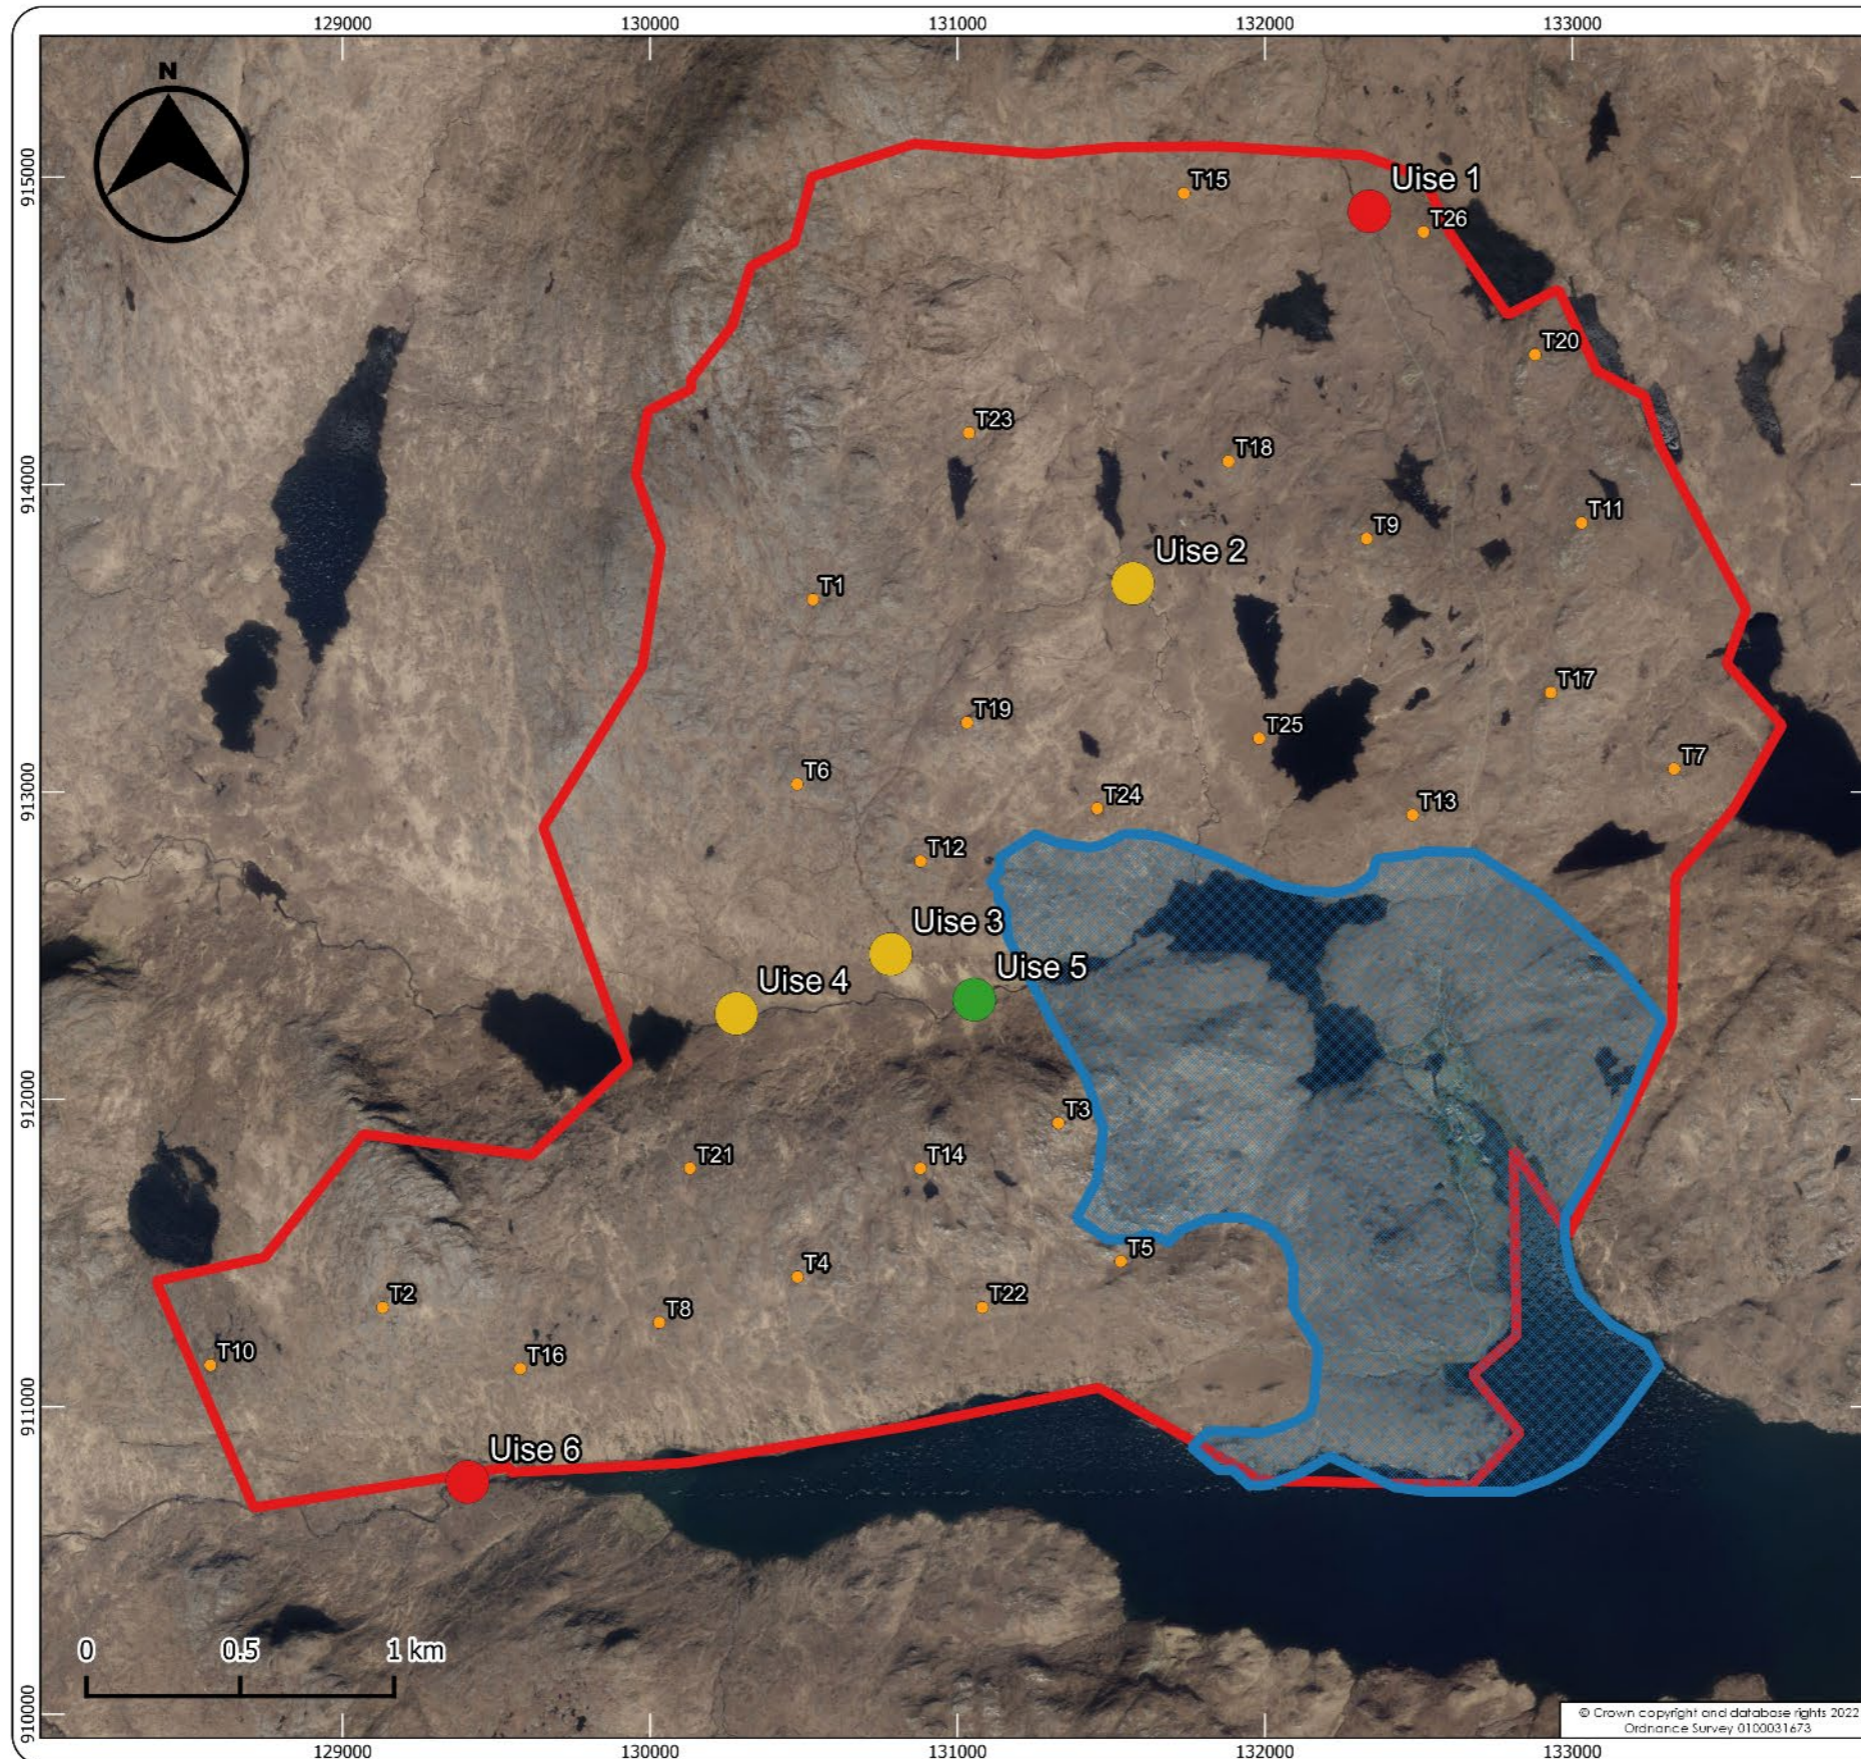
Figure Title:
Uisenis Spawning Habitat

Fish spawning habitat results ranged from Optimal (Uise 5), Sub-Optimal (Uise 2, Uise 3, Uise 4) and Not Suitable (Uise 1, Uise 6).

- Red Line Boundary
 - Estate Exclusion Zone
 - Turbine Locations
- Fish Spawning Potential**
- Optimal
 - Sub-Optimal
 - Not Suitable

As a result it is recommended that Redd counts are conducted in all survey locations of both Optimal and Sub-Optimal conditions to better assess the degree of spawning utilisation.

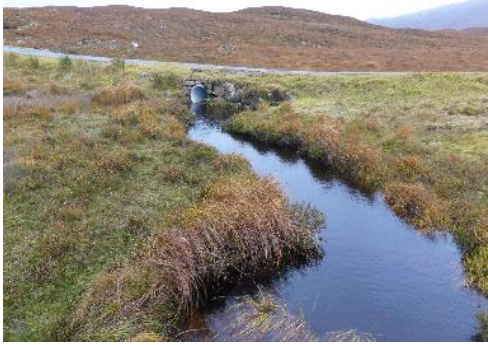
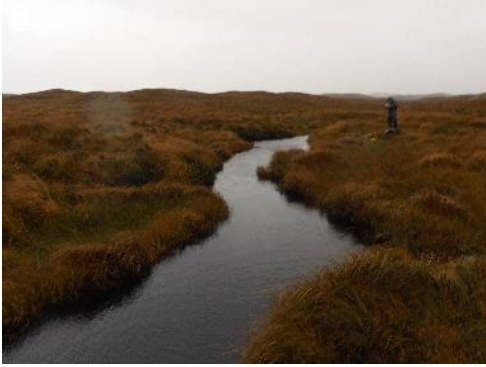
Survey Location	Downstream facing Upstream	Upstream facing Downstream
Uise 1

Fish Habitat Quality was determined to be **Moderate**. Uise 1 provided overall good quality for adult trout, however, was limited in providing habitat for salmon and other trout life stages. Substrate composition of cobble/high organic matter (both 50%) provided Sub-Optimal substrate for salmon/brown trout at all life stages. Flow type dominated by deep pools primarily >80 cm in depth provided Optimal habitat for adult brown trout and holding pools for spawning salmon, however, was unsuitable for fry and was out with the maximum depth preferences of parr. Bankside cover was excellent at 100% coverage on both sides, dominated by undercutting and roots on the left bank, and undercutting on the right bank. A culvert present provided additional anthropogenic fish cover but did not present a barrier to migration in the flow conditions present at the time of survey.

Spawning potential was determined to be **Not Suitable** due to a lack of qualifying Optimal and Sub-Optimal features. Substrate composition was 50/50 cobble/high organic matter with a notable absence of preferential gravel and pebbles, this was partly compacted. River depth provided Poor suitability with 95% of area surveyed unsuitable between 41-80+ cm in depth for both salmon and brown trout. Although no instream siltation was recorded the dominance of flow type as deep pool making this Not Suitable for salmon and Sub-Optimal for brown trout.

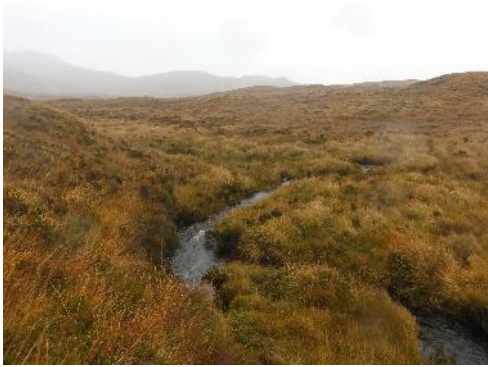
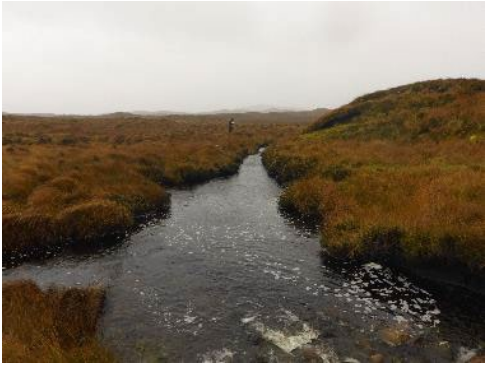
Uise 2

Fish Habitat Quality was determined to be **Good** due to the dominance of habitat suited to a wide range of life stages. Substrate was highly variable with gravel (5%), pebble (25%), cobble (50%) and boulder (20%), however, the dominance of coarser substrate types and notable lack of finer substrates makes the survey location Optimal for all life stages. The primary flow type of shallow glide (70%) is Optimal for all life stages. Areas of run (10%) and riffle (10%) are considered Optimal for juvenile salmon but are present only in small quantities. The dominance of depth ranging from 21-40 cm is Optimal for parr and considered Sub-Optimal for fry at their respective depth limits, and Not Suitable for adults. Both banks provide good coverage with 100% bank cover dominated by undercutting, root and rock presence.

Spawning potential was determined to be **Sub-optimal**. Substrate composition was primarily cobble (50%) and pebble (25%) with some gravel (5%) that was uncompacted providing Optimal conditions. Depth additionally provided Optimal conditions for both salmon and brown trout with 90% of water between 21-40cm with some additional area between 41-80cm in depth. Flow type was dominated by an Optimal shallow glide (70%) flow with smaller proportions of shallow pools (10%), run (10%) and riffle (10%) with no instream siltation. Although a dominance of Optimal features were observed, the area this covered was >10 m² at 6 m² and therefore did not qualify as Optimal under SFCC classification.

- Electrofishing surveys are conducted for all survey locations in a High or Good condition (Uise 2, Uise 4, Uise 5 and Uise) to provide baseline data for the actual salmonid populations and to further inform the species present within the Site;

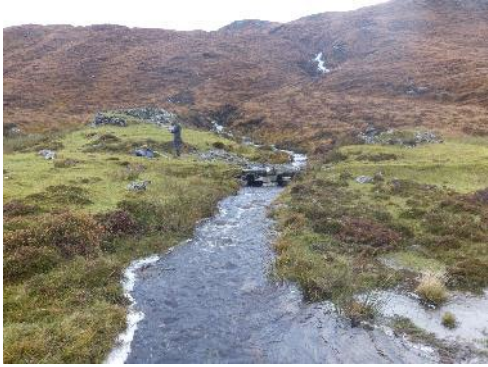
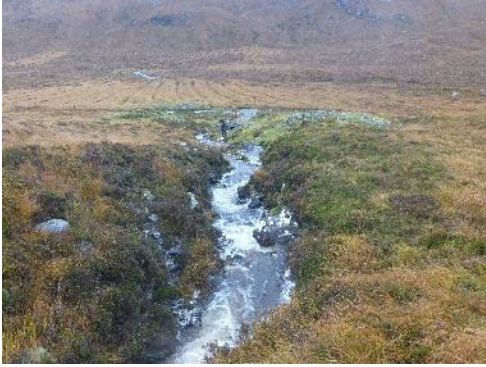
Uise 3

Fish Habitat Quality was determined to be **Moderate**. Substrate type ranged widely from gravel (10%), pebble (15%), cobble (20%), boulder (50%) and bedrock (5%). High coverage of coarser substrates provide Optimal habitat for salmonids at all life stages. Flow type was dominated by unsuitable torrent water (65%) with some Optimal riffle (15%) areas for salmon juveniles and Optimal shallow glide (20%) for all salmonids. Depths varied considerably throughout the survey location from 0-20 cm (10%), 21-40 cm (55%) and 41-80 cm (35%) providing minimal Optimal depth suitability for fry but large Optimal areas for parr. Both banks provide good fish cover at 100% (left bank) and 80% (right bank) as a result of undercutting, vegetation draping, and rock.

Spawning potential was determined to be **Sub-optimal** due to a mixture of Optimal and Sub-Optimal qualifying features and a lack of Not Suitable features. Substrate composition was primarily unsuitable boulder (50%) with areas of suitable substrate with gravel (10%), pebble (15%) and cobble (20%) providing overall Sub-Optimal conditions. Substrate was uncompacted with no siltation but substrate was unstable. Depth was primarily Optimal with 55% of water within 21-40 cm with Sub-Optimal shallower (0-20 cm) depths at 10% and deeper (41-80 cm) at 35% providing overall Sub-Optimal conditions. Flow type was dominated by unsuitable torrent water (due to the presence of a large waterfall within the survey location) at 65% with some Optimal areas present with shallow glide (20%) and riffle (15%) providing overall Sub-Optimal conditions. The useable spawning area was 15% and covered 3 m².

- Redd counts are conducted for all survey locations in Optimal or Sub-Optimal conditions (Uise 2, Uise 3, Uise 4 and Uise 5) during known spawning to assess the degree of spawning utilisation, to estimate the number of females spawners in a given survey location and to determine its relative importance in sustaining wider salmonid populations.

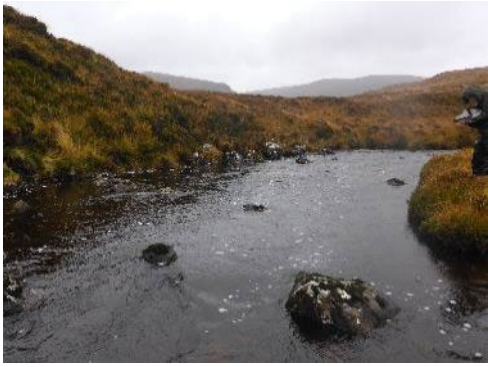
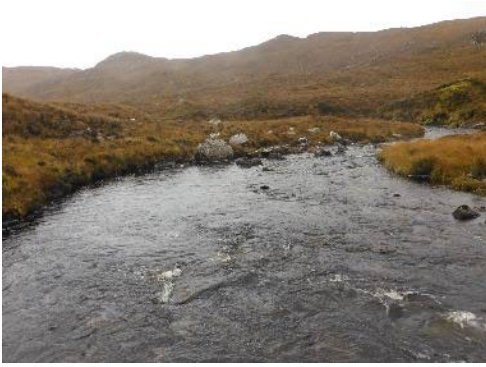
Uise 4

Fish Habitat Quality was determined to be **High**. Substrate was dominated by Optimal coarse substrate types primarily boulder (55%), cobble (25%) with unsuitable bedrock (10%) and fine substrates (10%) for all life stages present in lower percentages. Flow type was dominated by an Optimal riffle (40%) / run sequence (25%) for juvenile salmon and sub-Optimal area for brown trout. Still marginal (5%) and shallow glide (30%) flows provided Optimal flow types for salmonids at all life stages. Water depths were within Optimal ranges for salmonid parr but considered unsuitable for fry and out with preferred depths of adult salmonids and therefore Sub-Optimal. Bank cover was good with both banks recording 80% fish cover due to a dominance of bank undercutting and rocks.

Spawning potential was determined to be **Sub-Optimal**. Despite a dominance of Optimal fish habitat features, there was a lack of spawning substrate limiting spawning potential. Substrate was primarily unsuitable boulder (55%), high organic (5%), sand (5%) and bedrock (10%) with areas of Sub-Optimal cobble. Depth ranged from Optimal (30%) with some Sub-Optimal and unsuitable areas (combined 70%). Substrate was optimally stable and uncompacted with no siltation present. Flow type consisted of Optimal salmon areas, 40% riffle, with areas both Optimal for salmon and trout, run (25%), still marginal (5%) and shallow glide (30%).
